PCI 9030
Errata Rev. 1.6
December 2001

Errata Documentation

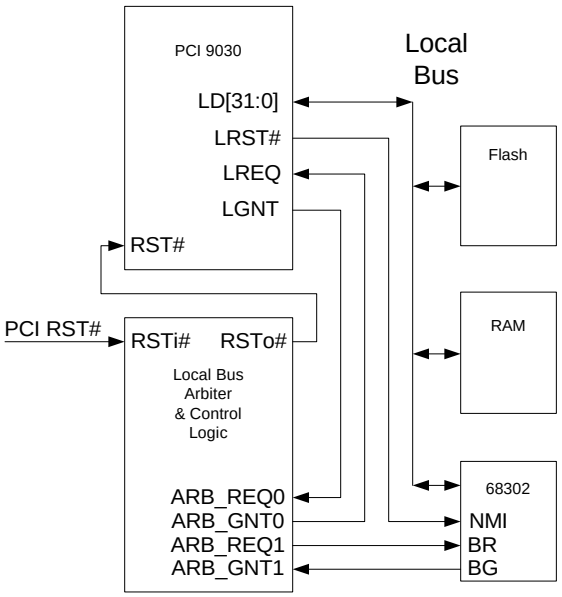
Block Diagram of one possible work around implementation

4. LA[27:24] / GPIO[4:7] multiplexed I/O pins, and Non-multiplexed Mode LD[31:0] data or Multiplexed Mode LAD[31:0] address/data I/O pins, are driven low during PCI reset

Problem: The PCI 9030 drives the LA[27:24] address pins (which can be configured as GPIO[4:7] pins after PCI reset completes), and Non-multiplexed mode LD[31:0] data or Multiplexed mode LAD[31:0] address/data I/O pins, low during PCI reset rather than to high impedance state. This may result in bus contention if other devices use these signals during PCI reset. The remaining address bus signals, LA[23:2], as well as the LBE[3:0]# byte enables, are floated during PCI reset.

Below is a block diagram of one possible implementation, showing only the relevant signals. The necessity of this workaround is required only if the user does not want PCI reset to generate a system/board reset. Because the PCI 9030 drives the LA[27:24], LD/LAD[31:0], and LRST# pins low as long its RST# is asserted, bus contention will occur on the local bus if other local bus devices are using the bus at that time. The workaround concept is as follows:

4. Create external logic that controls the local bus arbitration and captures PCI RST# to provide a conditioned RST# signal to the PCI 9030. The basic concept is to always request the local bus from the PCI 9030 and only grant the bus to PCI 9030 when it informs the system that it needs the bus by negating its LGNT pin. Below is a detailed description of this workaround.

- Capture the PCI RST#,
- "give" the local bus to the PCI 9030;
- assert a reset pulse on the PCI 9030 RST# pin for a minimum of 2 rising PCI clock edges;
- wait for the PCI 9030 to process its RST#;
- "take" local bus control back from the PCI 9030, resume normal local bus activity, prepare for the next PCI RST# after it negates

To allow another device or devices to be a master on the local bus, an external arbiter needs to be designed such that it takes the local bus from the PCI 9030 and only gives it back to the PCI 9030 when it needs it. This can be done by setting register CNTRL[7] = 0 and asserting LREQ (as early as power up). Then the only time the PCI 9030 gets the local bus back is when it negates LGNT (preempt condition, indicating it has a pending command - only if CNTRL[7] = 0), and the external arbiter grants the PCI 9030 the Local bus by negating LREQ. The arbiter can then reassert LREQ a minimum of one clock after it was negated and wait for LGNT to be asserted before taking the Local bus back over. Depending upon the system, the user may want to customize their solution to allow windows of access depending upon expected activity.

The workaround requires the PCI 9030 RST# signal to be asserted for a minimum of two PCI rising clock edges. If you only have access to the Local clock then you would need to determine the minimum frequency of PCI operation. A close approximation is - Minimum PCI frequency = 2.01 x 1/period, where period is the amount of time you assert RST#. If the PCI clock is available for use, the design can be constructed to ensure RST# is asserted for two rising edges, and using the PCI clock will allow the design to work down to 0.0 MHz. LREQ may be asserted before, during and/or after RST# and LRST# assertion.
